Updating Vision HW to v2.5.0 on Routed Networks

Autoscope Vision

Document Number: AN2170

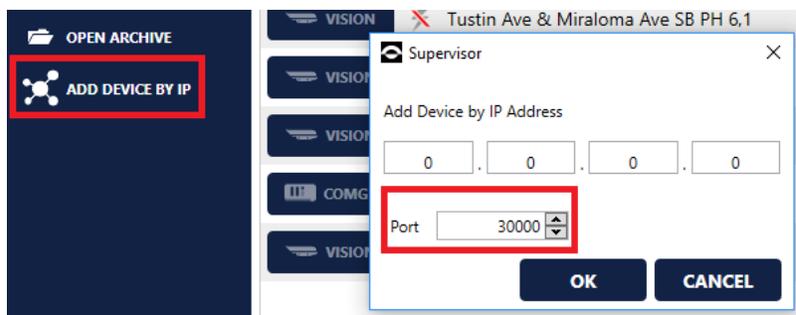
- 1) Open the Supervisor v2.5.0 software, click the “Add by IP Address” selection to add the Comm Managers and their connected Sensors into Supervisor. Repeat this process for each Comm Manager.

- 2) Add in the IP address of the Comm Manager as you had done when adding to the previous Supervisor version, except replace the default port of 30000 shown in the new port selection area to port 51516 (the default for previous versions), then click "OK".
- 3) After clicking "OK" and the devices are added into the Supervisor list, go ahead and update them to v2.5.0 firmware as you would normally.
